**UNITED STATES
DEPARTMENT OF THE INTERIOR
FISH AND WILDLIFE SERVICE
Ecological Services**
Suite D, 3530 Pan American Highway, NE
Albuquerque, New Mexico 87107

~~July~~ ^{August} 29, 1989

This report summarizes investigations by the U.S. Fish and Wildlife Service (Service) pertaining to mitigation tree planting for the Corps of Engineers (Corps) project "Cuchillo Dam, Truth or Consequences Unit, Rio Grande Floodway, Sierra County, New Mexico." The Service submitted a Fish and Wildlife Coordination Act Report to the Corps in May, 1986 which included a recommendation to establish four acres of trees to mitigate wildlife impacts of the proposed Cuchillo Dam. The Corps requested the Service develop a detailed plan for the mitigation. In a letter to the Corps dated November 17, 1988 the Service concluded, that as a result of personal studies, cottonwood establishment in the floodpool of Cuchillo Dam was not feasible. This report contains a detailed evaluation of the conditions along Cuchillo Negro Creek relative to tree planting.

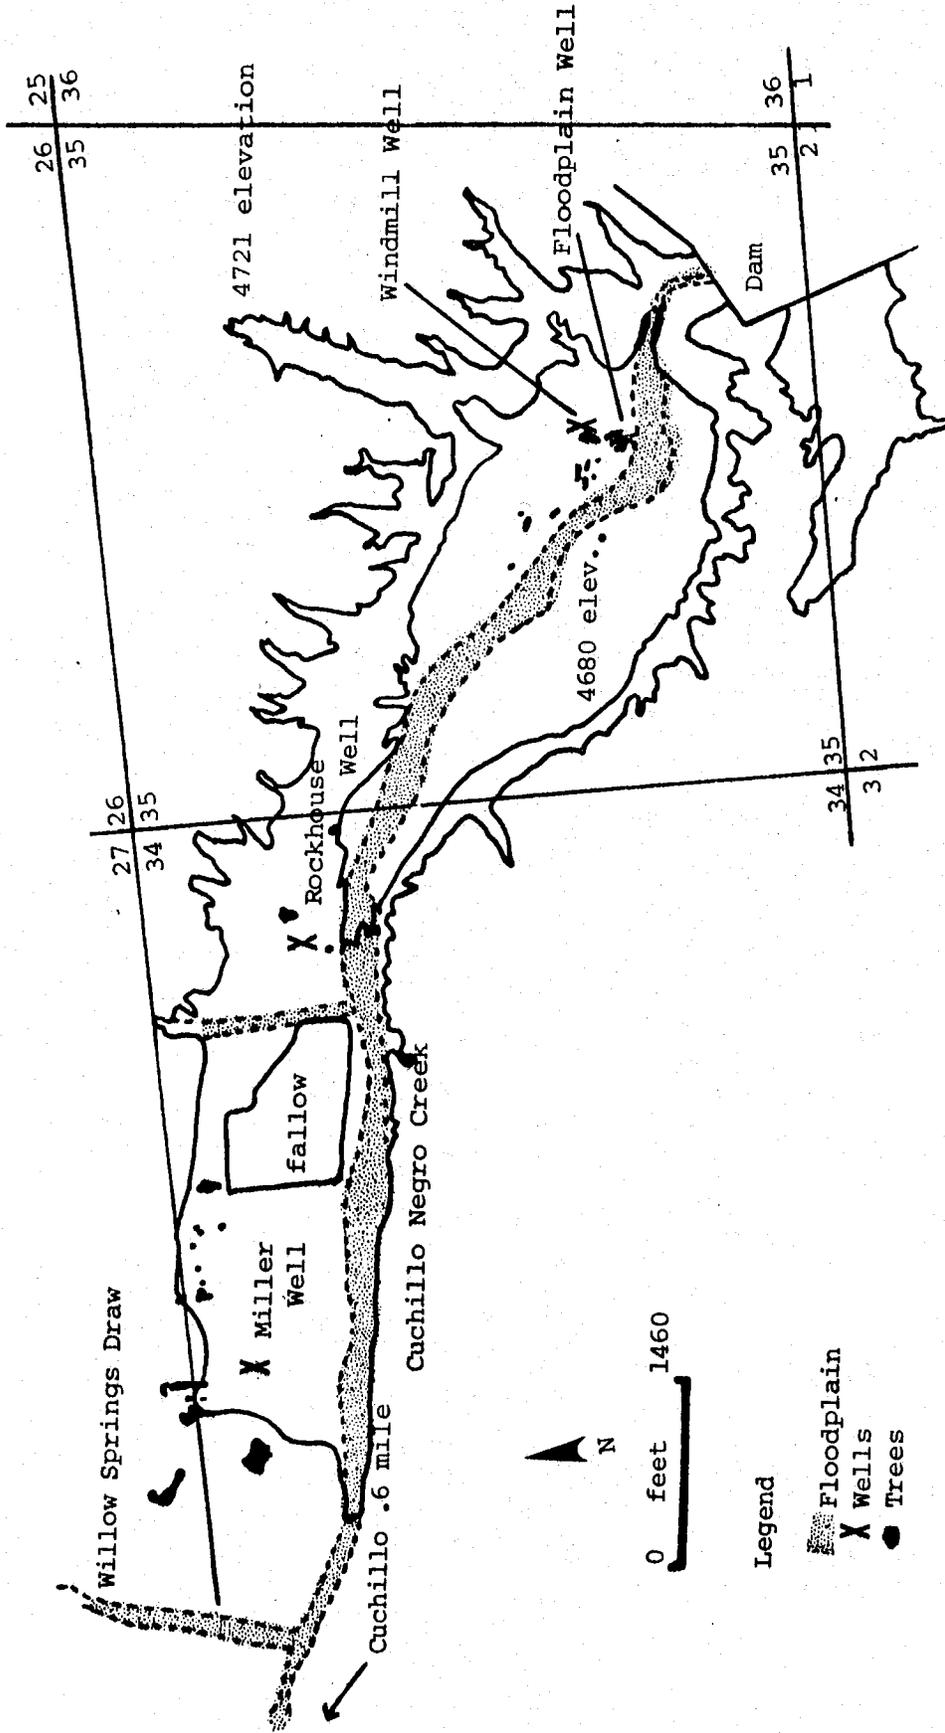
Figure 2. Wells in the Proposed Cuchillo Dam Floodpool where Ground Water Table Measurements were Taken.

During the growing season (July through September) water depth was measured at four wells (Table 1 and Figure 2). Ground water was deepest at the Miller well, 21 feet, and shallowest at the floodplain well, 1.9 feet. Even though the water table is near the surface at the floodplain well, planting cottonwoods there would not be advisable because flood flows constantly scour the gravel in the area. The only feasible location for trees is on the adjacent land terrace which is about four feet above the floodplain. However, it would be hard to establish trees on the terrace because of the difficulty of obtaining poles over 12 feet long and the problems of digging a hole to the proper depth. Pole planting sites should have a water table that is from 1 to 10 below the surface.

In summary, we recommend against cottonwood pole planting in the Cuchillo Dam floodplain because of the deep water table, scouring and siltation events and the poor success of poles already planted in the area. We suggest the Corps explore alternate vegetation sites or use more drought tolerant trees and shrubs. Areas located in floodplains with a permanent water flow such as the Rio Grande would be desirable. We have contacted the Bureau of Reclamation about planting trees in suitable areas along the Rio Grande upstream of Caballo Reservoir. They have no objection to the Corps using the area for mitigation provided they, the Corps, fund the project. The Plant Materials Center, located at Los Lunas, New Mexico should be able to provide the Corps with more suitable trees and shrubs for the Cuchillo area.

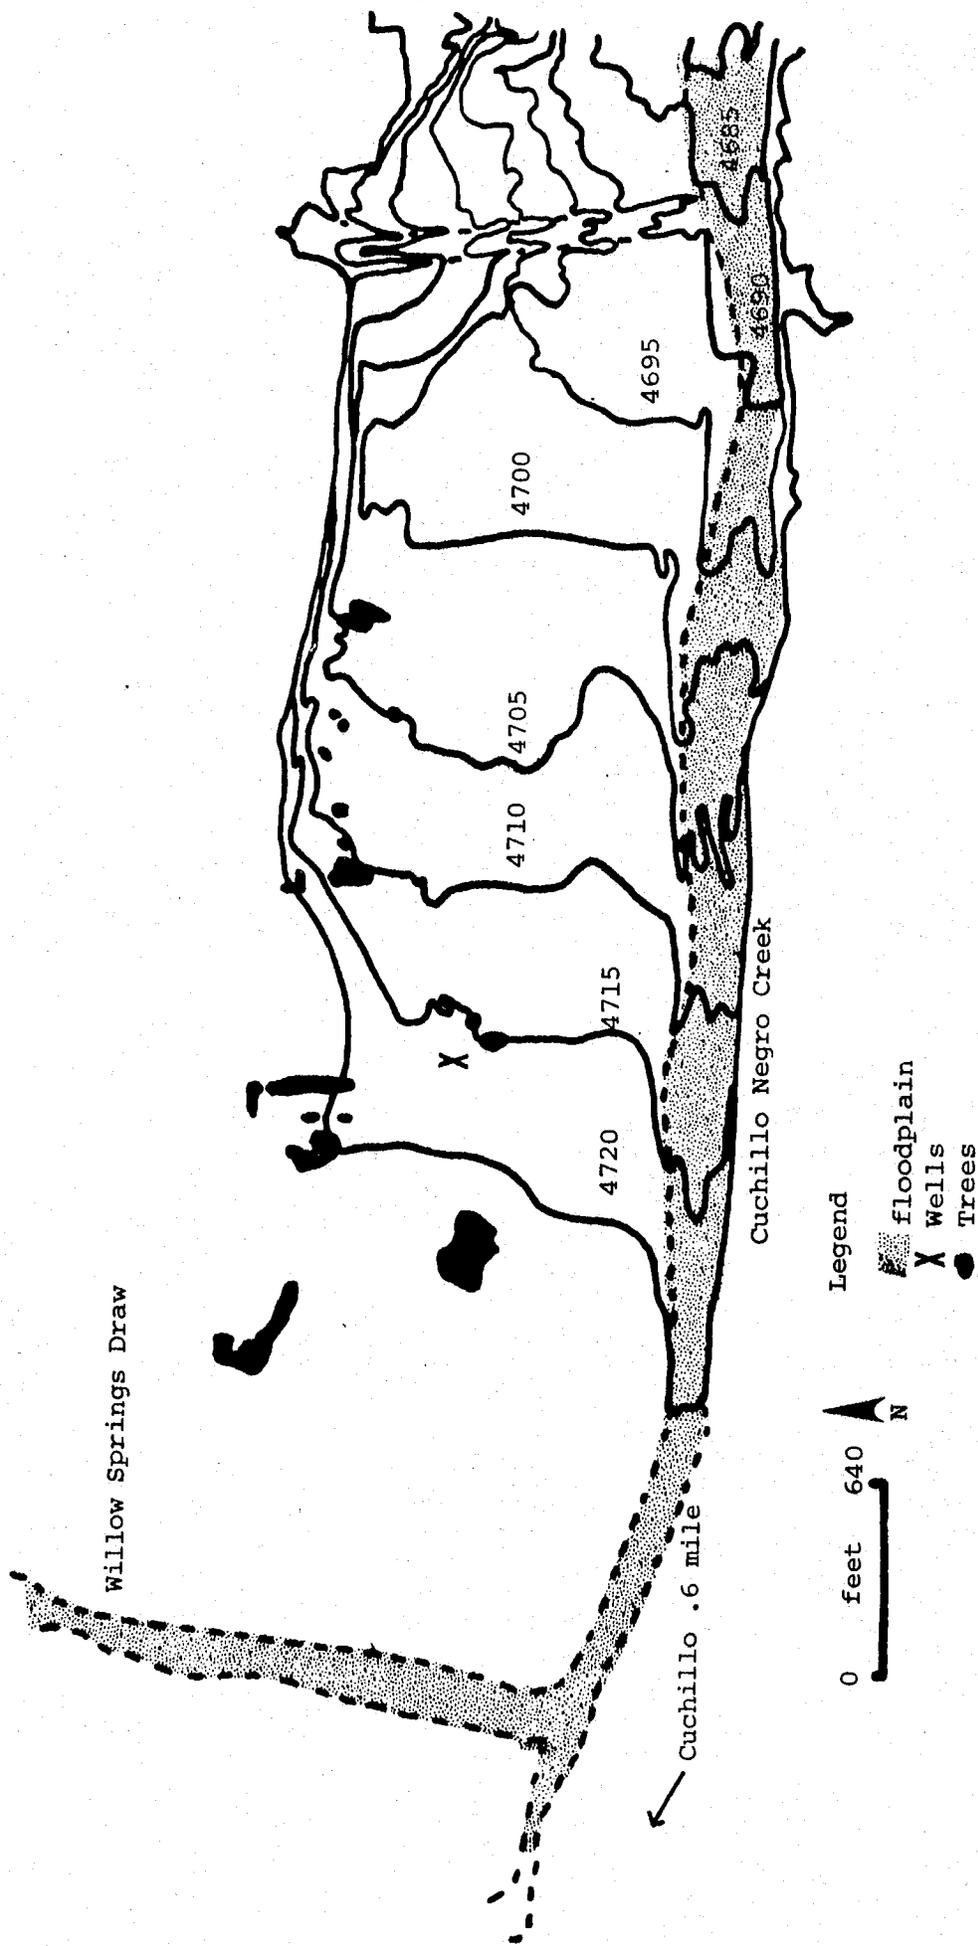
Figure 3. Elevation Contours of the Proposed Cuchillo Dam, Upper Portion, Downstream of Cuchillo, New Mexico.

Elevation contours of the proposed floodpool area are presented in Figures 3 and 4. The ground water is deepest at the upper end of the floodpool area and shallowest near the damsite. Even if trees could become established in the shallowest ground water areas, flood flows may scour them out or bury them in silt. The Corps has predicted over the 100 year life of the dam that 63 feet of silt will be deposited.
